Evaluation Report

555

NEW HOLLAND 855 Round Baler

NEW HOLLAND 855 ROUND BALER

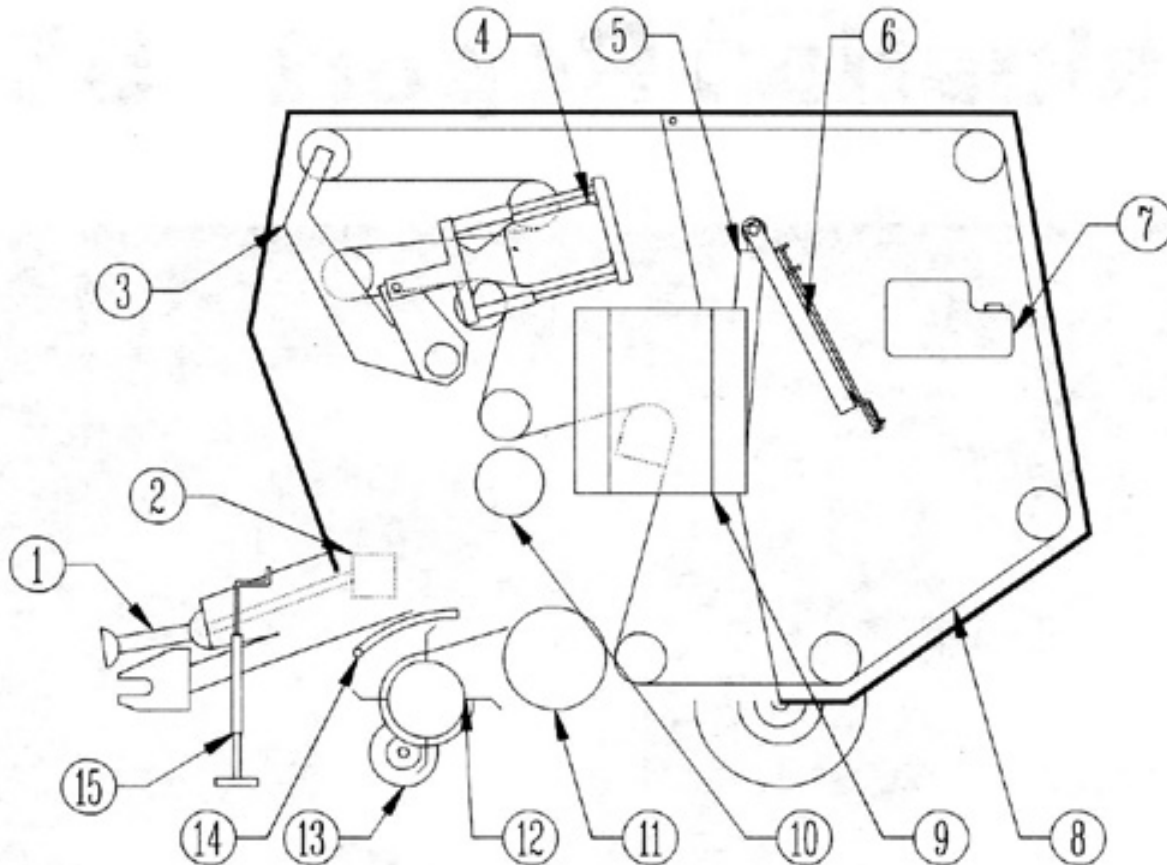
FIGURE 1. New Holland 855 Round Baler: (1) Drive Shaft, (2) Gearbox, (3) Apron Chain Tension Pivot Arms, (4) Air Springs, (5) Hydraulic Cylinder, (6) Hydraulic Cylinder Lockout, (7) Chain Oilers, (8) Apron Chain, (9) Twine Box, (10) Stripper Roll, (11) Floor Roll, (12) Pickup, (13) Gauge Wheel, (14) Windguard, (15) Jack.

The New Holland 855 is a pull-type, PTO driven baler with a cylindrical baling chamber and a floating drum pickup. The twine wrapping mechanism is totally automatic. Dual twine guide tubes are driven either hydraulically or by electric actuator, depending on the option chosen. Both bale size and number of wraps can be manually set.

Detailed specifications are given in APPENDIX I, while FIGURE 1 shows the location of major components.

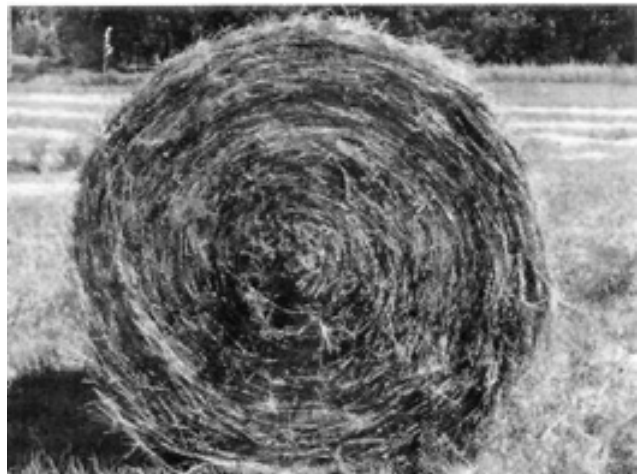
FIGURE 2. Typical Hay Bale.

Bale Quality: The New Holland 855 produced firm, durable bales with flat ends and uniform diameter in all hay crops (FIGURE 2). The Bale Command could be programmed to wrap the bale as many times as desired, however baling short straw generally resulted in a less durable bale. If the Bale Command direction indicators were followed exactly, a cone shaped bale or a bale with the core sticking out of one end would often result. A better bale usually resulted if the operator weaved back and forth across the windrow to form the core of the bale, and then followed the Bale Command once the bale started to grow. The operator quickly learned through experience when to follow the Bale Command. Usually a small adjustment of the full bale activator chain would prevent cone shaped bales.

A typical hay or straw bale averaged 5.9 ft (1.8 m) in width and 5.1 ft (1.6 m) in diameter. Bales usually settled to 89% of their original height after 100 days. Average hay bales weighed from 1200 to 1400 lb (540 to 640 kg) with average densities ranging from 10.0 to 11.6 lb/ft³ (160 to 186 kg/m³). Average straw bales weighed from 850 to 1100 lb (390 to 500 kg) with average densities ranging from 7.1 to 9.1 lb/ft³ (114 to 146 kg/m³). The manufacturer recommends not exceeding a maximum bale weight of 1700 lb (770 kg) to avoid damaging the baler.

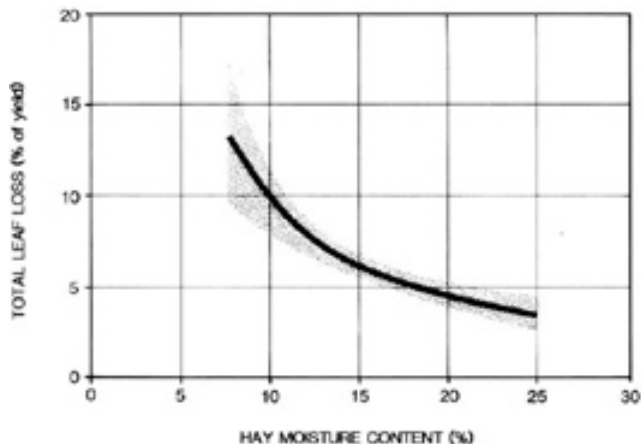
FIGURE 3. Typical Round Baler Leaf Loss in Mixed Alfalfa, Crested Wheatgrass and Bromegrass.

The importance of baling at a high moisture content on losses can be noted in FIGURE 3. This figure represents an accumulation of previous data for several round balers showing the total measured leaf loss over a range of moisture contents, in fields of mixed alfalfa-crested wheatgrass and bromegrass. Although the New Holland 855 was tested in a different crop, its performance was above that presented in the figure, i.e. losses were lower.

FIGURE 3 does not include relative effects of baling unconditioned or light windrows. Heavy, conditioned windrows are important to minimizing losses. Lowering PTO speed is also effective in reducing the number of times the bale is turned in the chamber, and consequently reducing leaf loss.

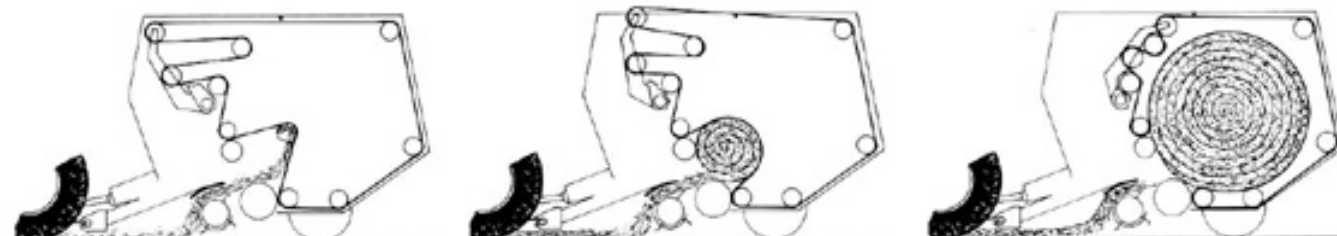
FIGURE 4. Stages of Bale Formation: (Left) Starting Bale, (Centre) Partially Completed Bale, (Right) Completed Bale.

Bale Forming: Ease of bale forming was very good in most crops. Feeding hay across the width of the bale chamber by weaving was essential to form a uniform core which did not stick out on one end of the bale. After the core was formed, the direction indicators on the Bale Command could be followed to produce bales of uniform diameter. FIGURE 4 shows stages of the bale formation in the New Holland 855.

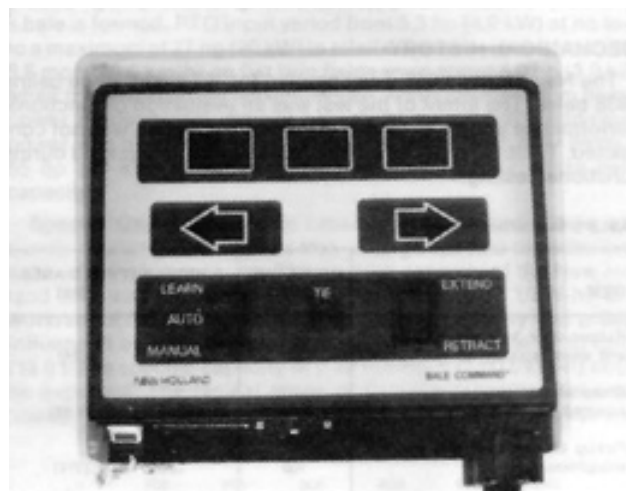
FIGURE 5. Bale Command Control Box.

The Bale Command is a tractor mounted control box which signals the operator when the baler is ready to form a bale, when to stop so that the bale can be wrapped with twine and when to eject the bale. It also signals the operator which direction to load the bale chamber to form an evenly shaped bale, and it can be used to program the wrapping cycle as well as wrap the bale prematurely.

Bale Wrapping: Ease of bale wrapping on the New Holland 855 was excellent since it was totally automatic. The Bale Command (FIGURE 5) cued the operator when to stop so the bale could be tied. When the red stop light came on and the horn sounded, the dual twine tubes would swing to the outside of the bale according to the preprogrammed wrapping cycle. It was generally advisable to continue forward motion of the tractor for a brief period of time after the stop light came on to ensure that the twine was properly started into the bale.

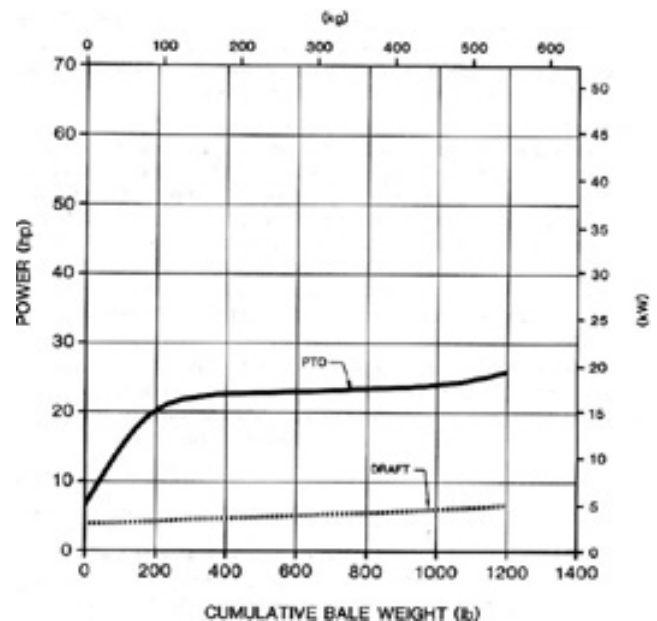
FIGURE 6. Power Consumption During Bale Formation in Alfalfa.

Power Requirements: FIGURE 6 shows the PTO and drawbar power requirements for the New Holland 855. The power input is plotted against bale weight to show the power requirements while a bale is formed. PTO input varied from 5.3 hp (4.0 kW) at no load to a maximum of 27 hp (20 kW) in alfalfa. Drawbar requirements at 6.6 mph (10.6 km/h) on flat firm fields were about 4.0 hp (3.0 kW) when the bale reached maximum size. Although maximum horsepower requirements did not exceed 31 hp (23 kW), additional power was needed to suit field conditions. In soft, hilly fields, a 65 hp (49 kW) tractor would be needed to fully utilize baler capacity.
